### 2.1.5 Accident History

Route 6 Hop River Corridor Transportation Study

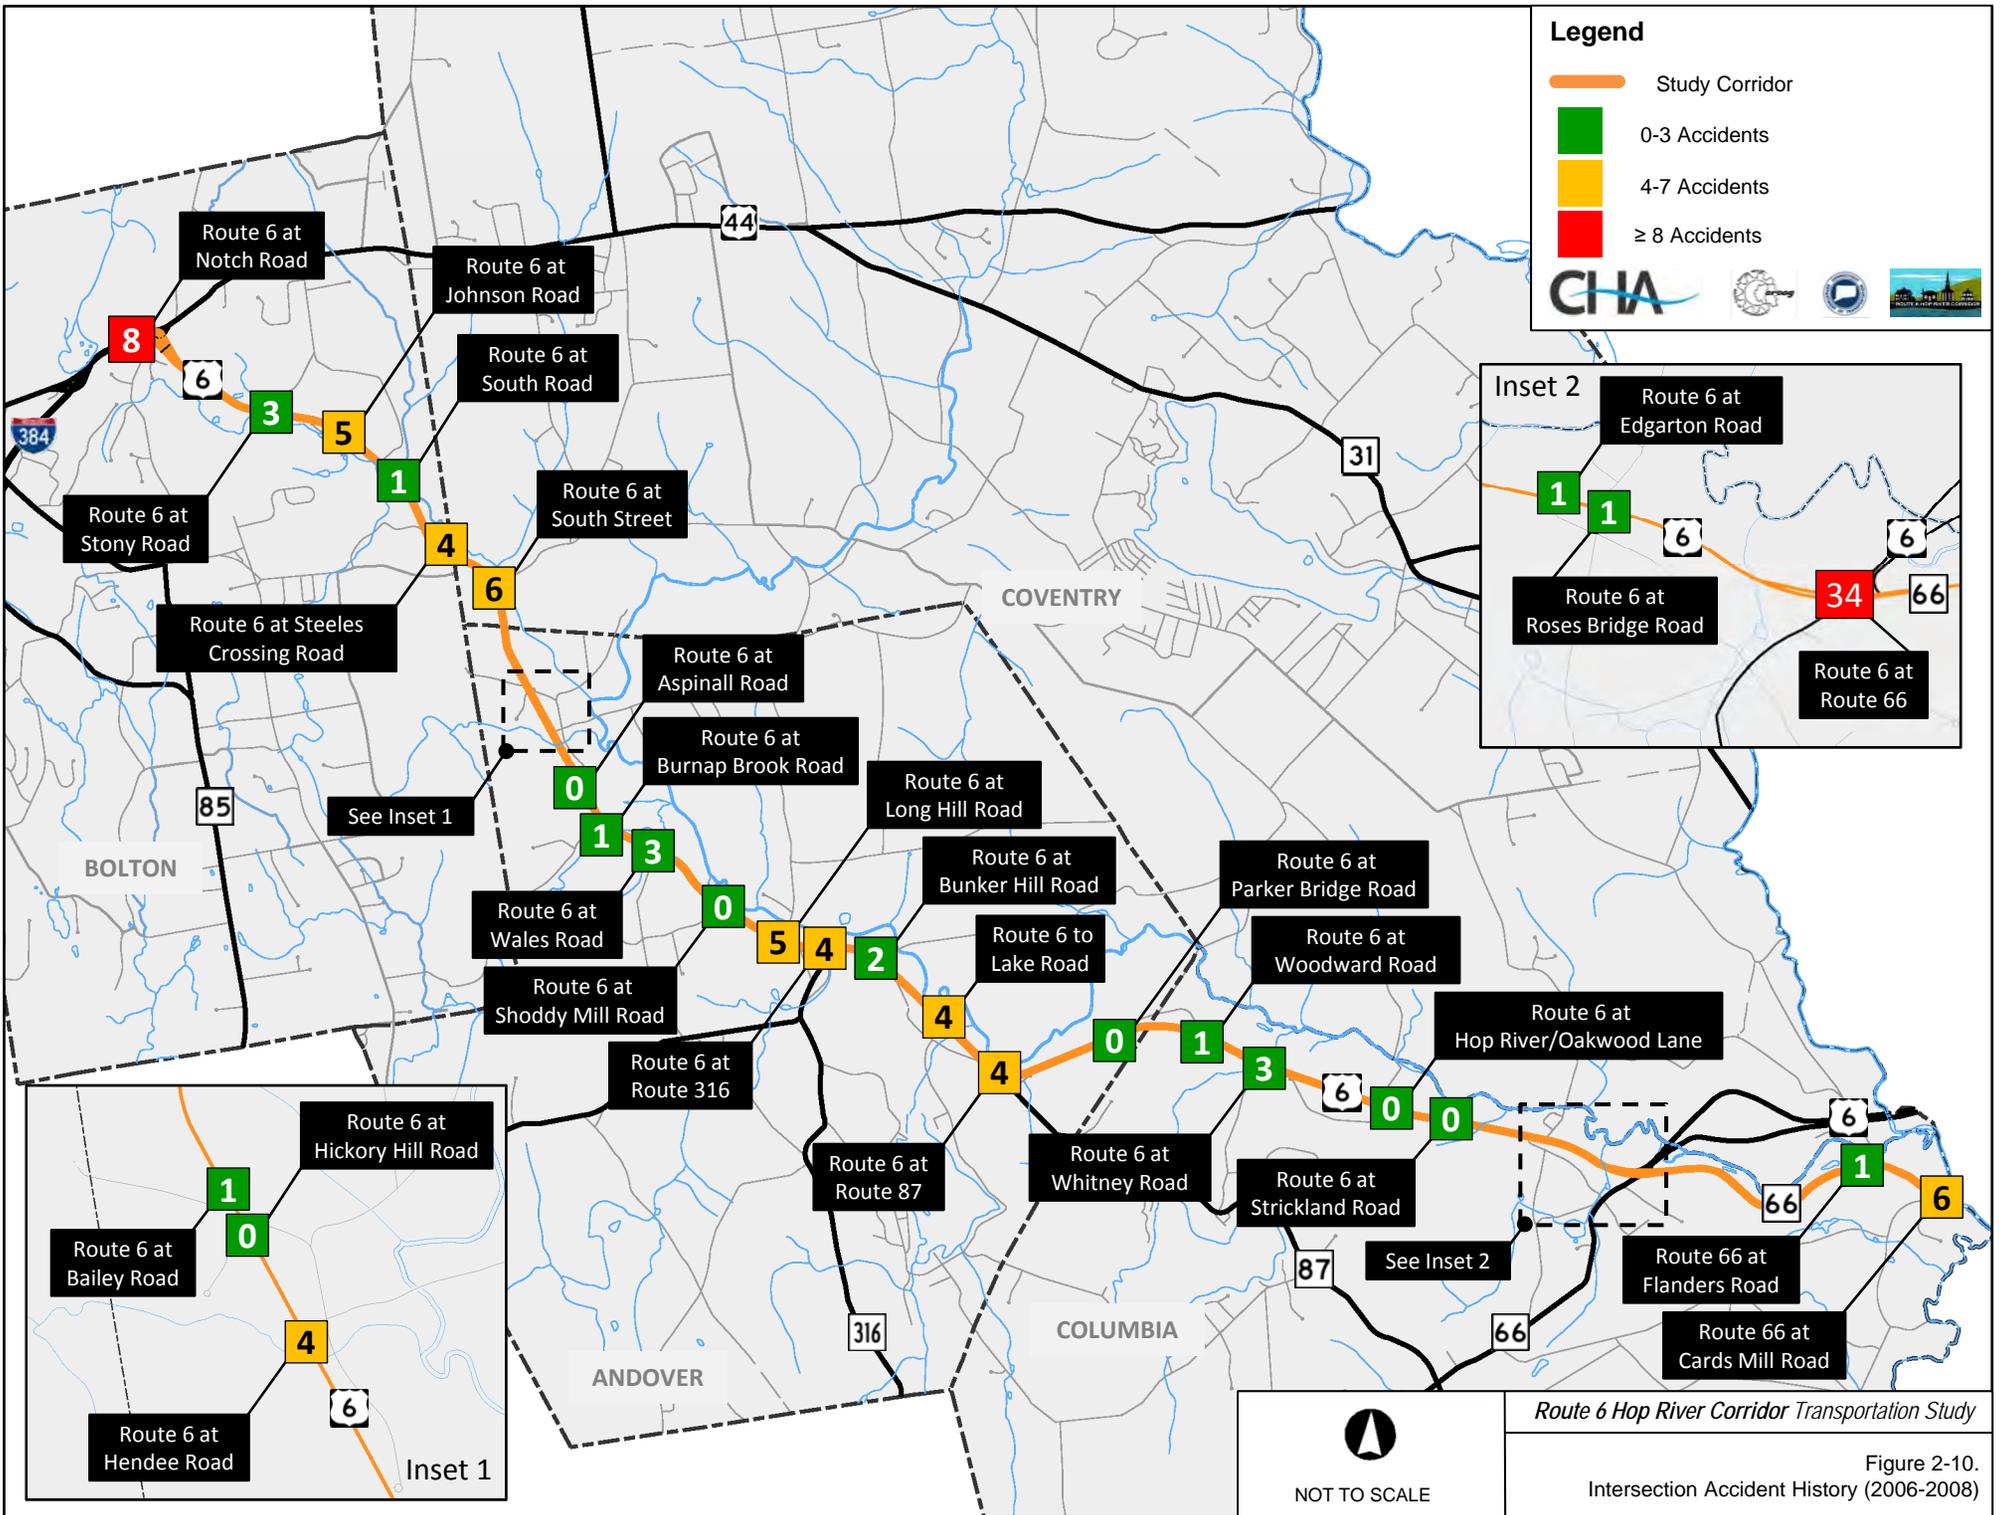
Figure 2-10. Intersection Accident History (2006-2008)

Figure 2-10 and Table 2-10 detail the accident history at each side road intersection.

- Turning-related collisions constituted 33% of all accidents (2 of 6). Both of these accidents were caused by vehicles turning left from South Street and colliding with through vehicles (one eastbound and one westbound) on Route 6. The relatively steep approach grade of South Street, which requires additional acceleration and time for a vehicle to complete a turn, and the left and right turn lanes on Route 6, which require additional distance and time for a vehicle to complete a turn, could be factors in these turning-related collisions involving left-turning vehicles from South Street.

- **Cards Mill Road at Route 66 East.** Six accidents in three-year period. Notable patterns include:
  - Rear-end collisions constituted 33% of all accidents (2 of 6) in the three year period at this unsignalized intersection. These accidents occurred on the heavily skewed, stop-controlled Cards Mill Road approach to Route 66 East and were attributed to vehicles following too closely. Skewed approaches like the Cards Mill Road approach are often treated by drivers (who are making the oblique turn) as yield conditions and rolling stops because little reduction in speed is required to complete the turn. Consequently, when two vehicles are approaching the intersection and the driver of the second vehicle anticipates that the driver of the first vehicle will yield rather than stop at the intersection, rear end collisions oftentimes will result.

- One turning, one sideswipe, one overturning, and one fixed object collision constituted the other four accidents at this intersection. These accidents were attributed to excessive speeds and failure of motorists to grant the right of way. The variety in the types of collisions and these contributing factors do not indicate any other particular site condition at this intersection that should be investigated further.

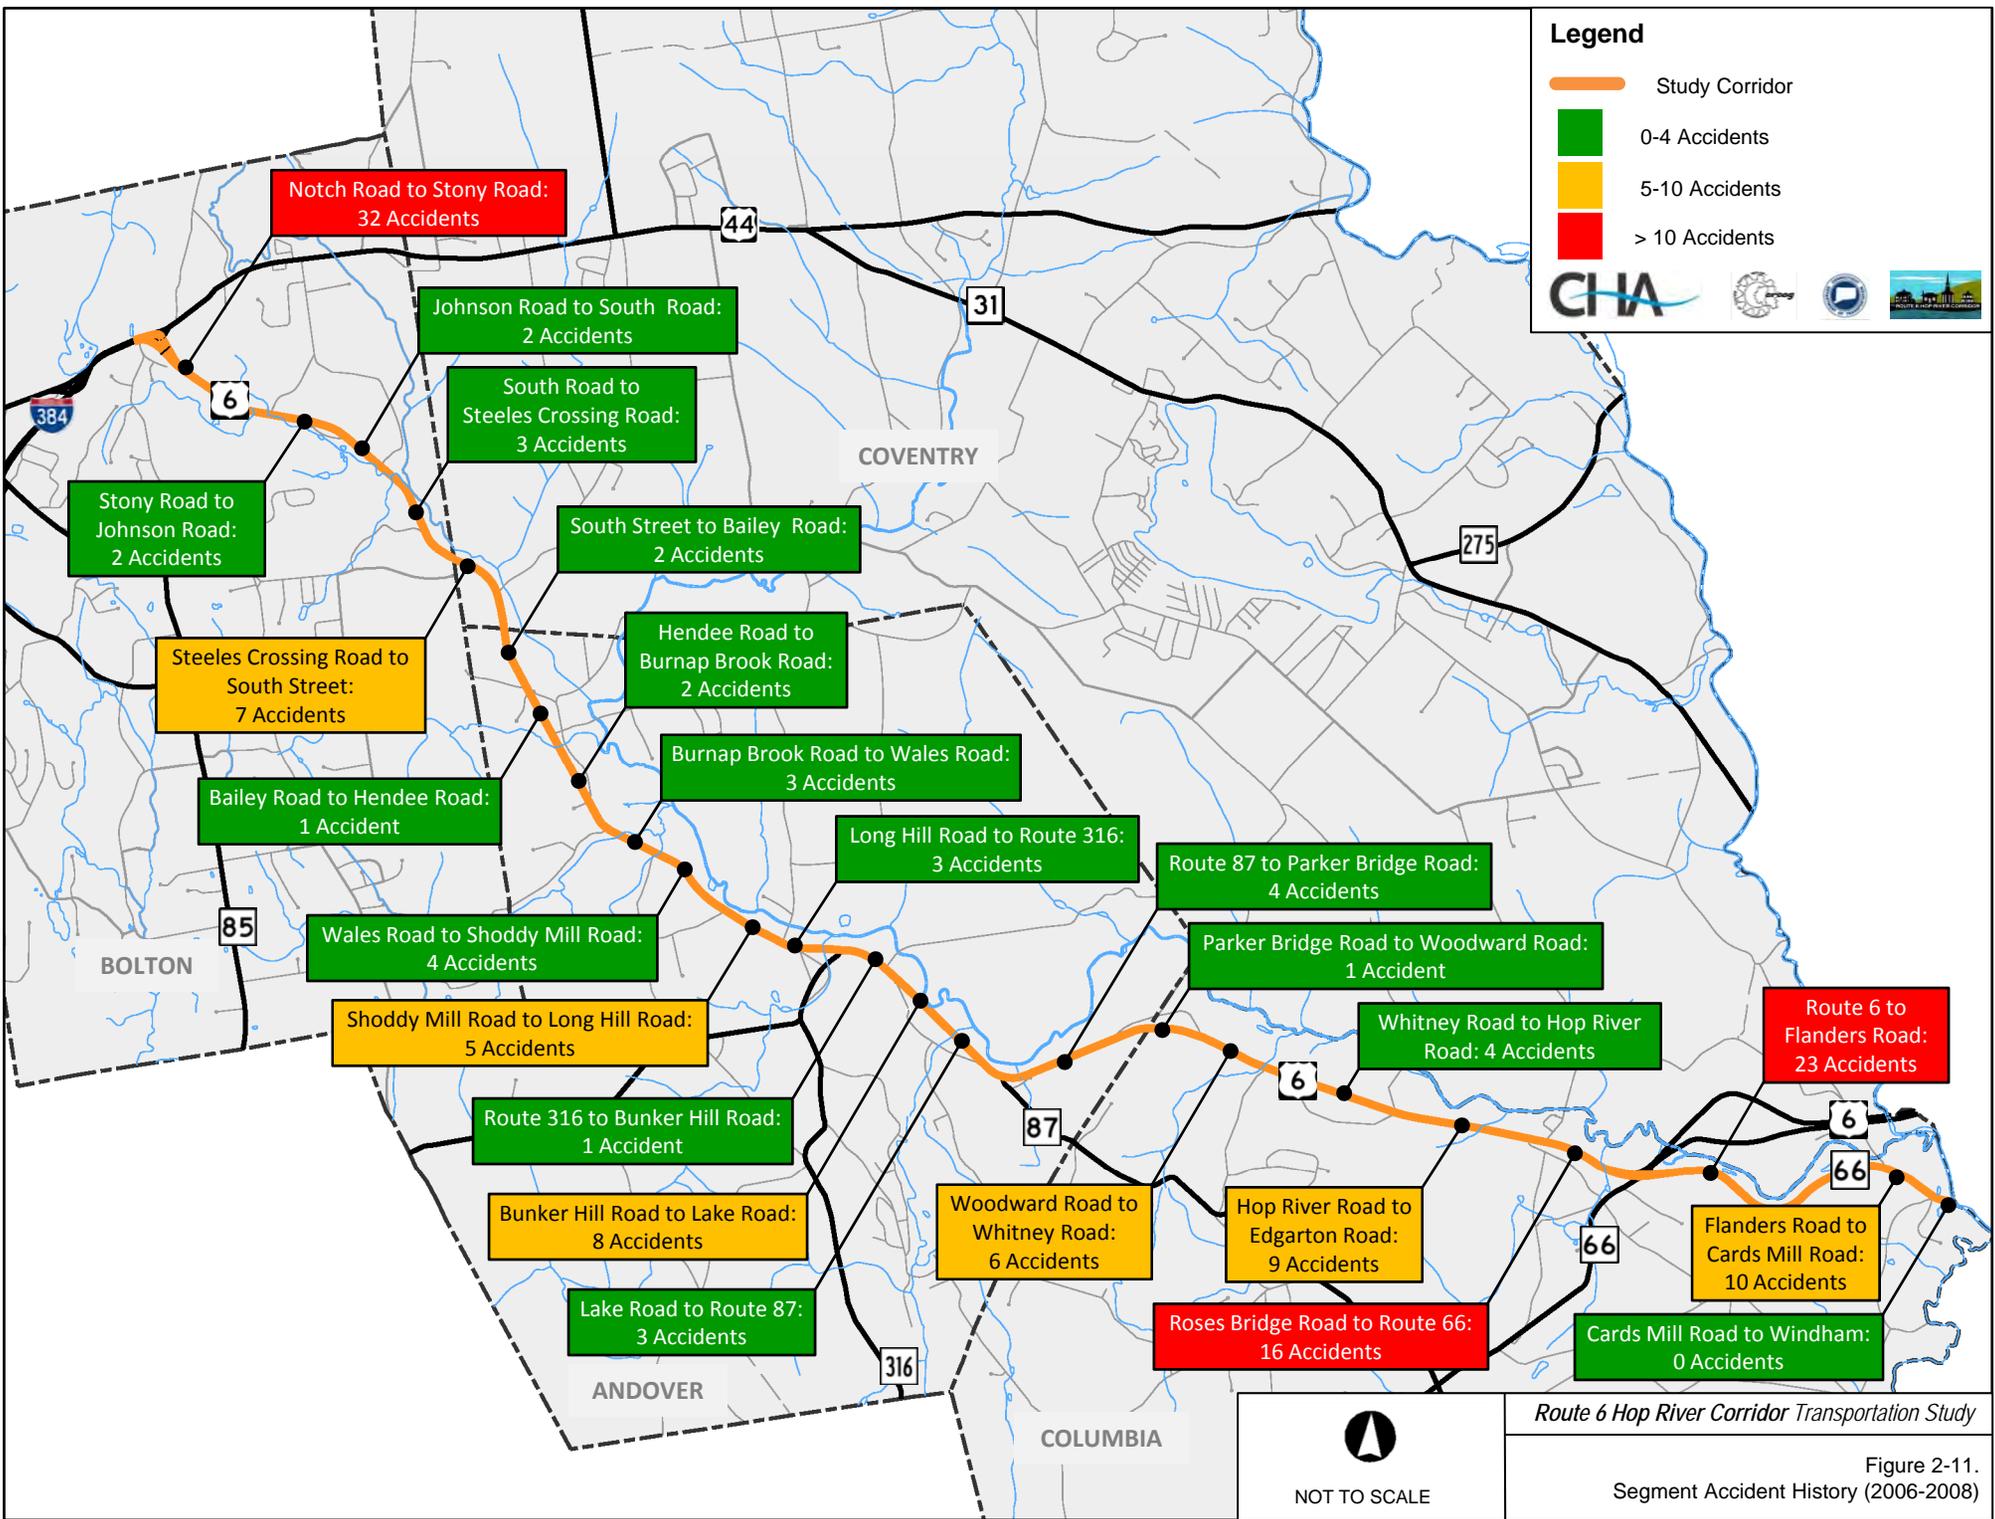
Figure 2-11 and Table 2-11 detail the accident history along each roadway segment (between intersections) in the study corridor.

- **Route 66 between Route 6 and Flanders Road.** Twenty-three accidents occurred in the three-year period, of these:
  - Fourteen (61%) accidents were fixed object collisions predominantly attributed to excessive speeds and drivers losing control. There were no areas where a concentration of accidents would indicate that a specific site condition has contributed to the number of fixed object collisions in this segment. The relatively narrow shoulders throughout the segment and the generally curving alignment could be contributing factors.

Although one may feel that the number of accidents along any particular segment of the Route 6 Hop River corridor might appear high, analysis of the local accident data does not suggest a deficiency in vehicular safety along any particular segment when compared to statewide accident data.
